NISTIR 6938

EXPERIMENTAL TESTING OF ROOF TO WALL CONNECTIONS IN WOOD FRAME HOUSES

Michael A. Riley and Fahim Sadek

April 2003

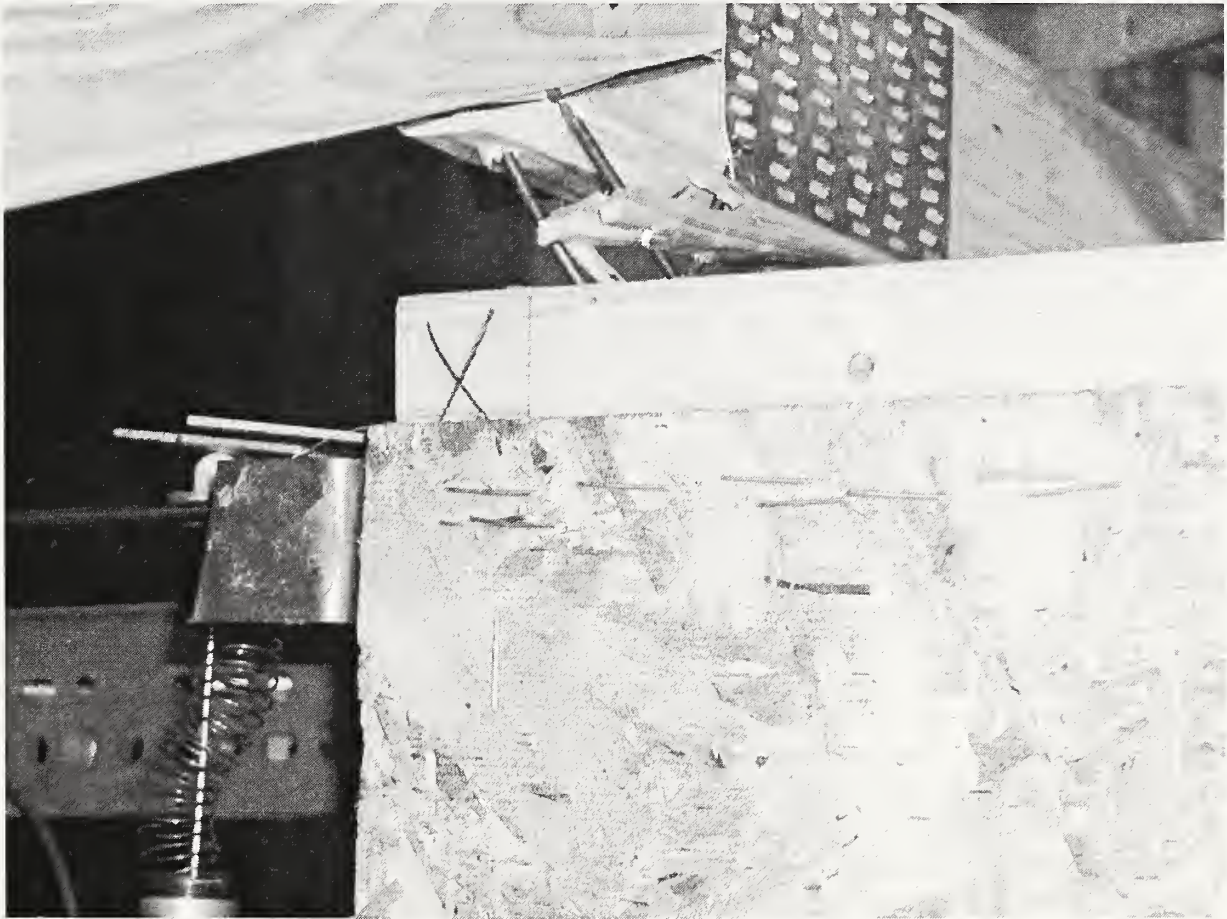
Figure 3.1. Failure of toe-nailed truss to wall connection.

Figure 3.4 shows the deformation that occurred at two connections during the test. The outer connection, truss 4, failed first. The drop in the deformation for this truss occurred near the end of the test, when the opposite outer connection finally failed. Truss 2 is an inner truss, and was the third of the four connections to separate completely. The load-deformation curves for these two connections are shown in Figure 3.5.

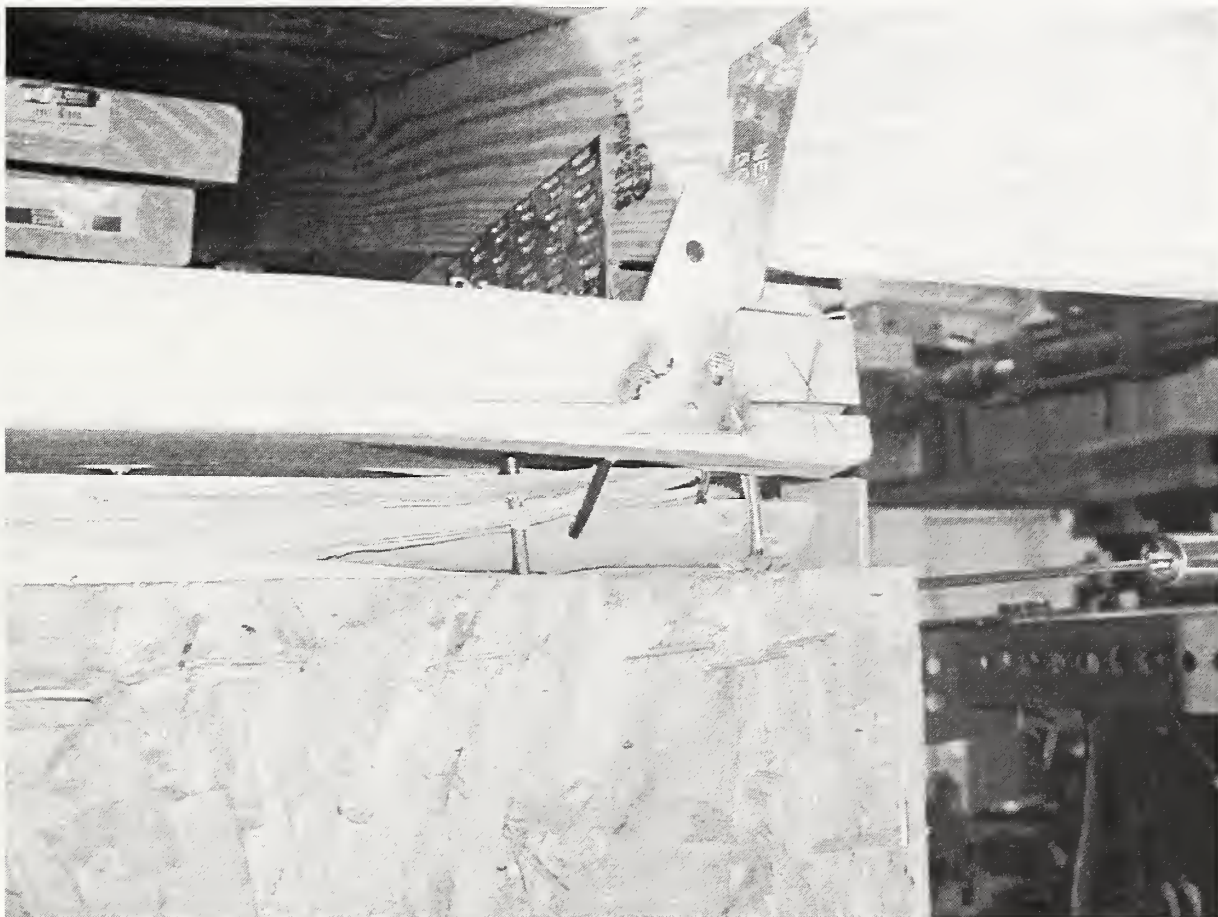
The specimen with the stronger hurricane clip connections was tested twice. The first failure occurred on the lightly instrumented side of the specimen, and consisted of the entire top plate pulling loose from the wall studs and cladding. The specimen was repaired and retested. During the second test, failure was observed on the other side in the walls' top plate, as can be seen in Figure 3.6. The hurricane clip remained attached to the upper member of the top plate and the truss, while the upper member of the top plate and a portion of the lower member separated from the rest of the wall. This failure mode clearly illustrated the improved strength of the hurricane clip connection.

Figure 3.6. Failure of hurricane clip connection.

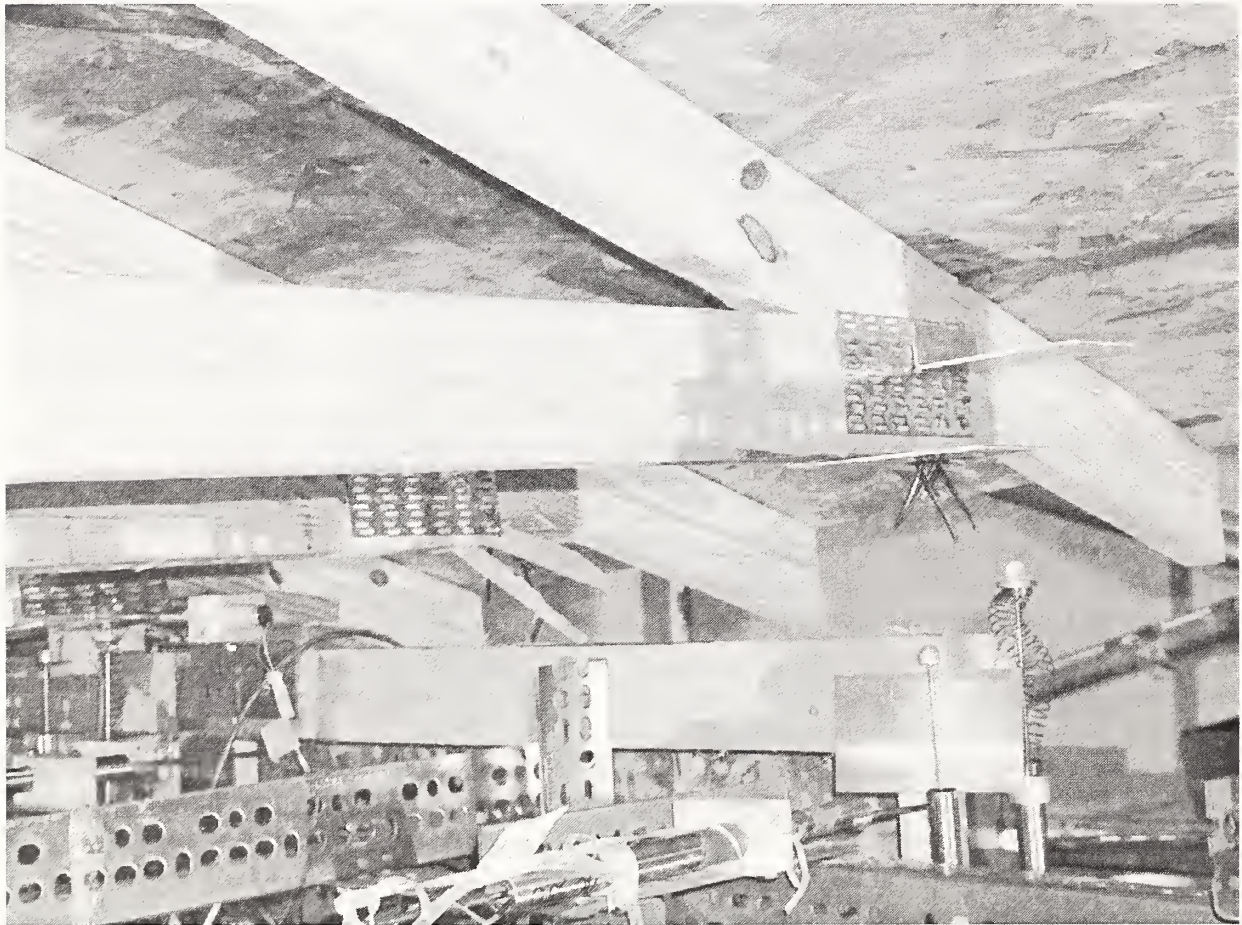
For the specimen with toe-nailed connections, the lateral deformation was applied at a constant rate of 12.7 mm/min (0.50 in/min) for a period of about 330 s, as can be observed in Figure 4.2. The resulting load is shown in Figure 4.3. The specimen resisted the applied load with constantly decreasing stiffness, until about 270 s into the test. At this point, the tension, due to the overturning moments, in the connections at one end caused the outer truss to pull free of the top plate. This failure can be seen in Figure 4.1. As in the case of the uplift loading, the failure mode can be characterized as nail withdrawal from the top plate. This failure resulted in the wood splitting in the bottom chord of one inner truss, but little damage to the wood of the outer truss.

Figure 4.1. Failure of toe-nailed connection with lateral load.

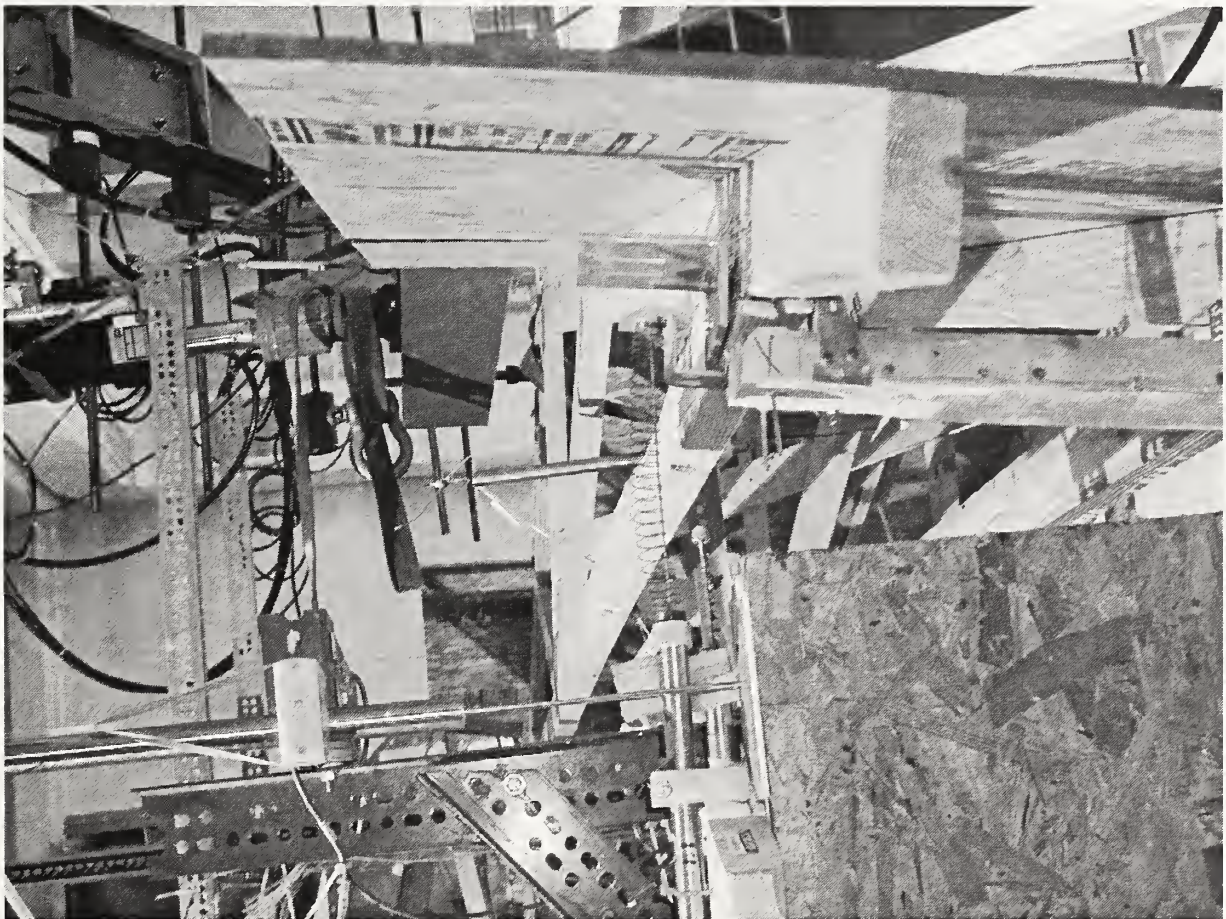
For the specimen with hurricane clips, the lateral deformation was applied at a constant rate of 25.4 mm/min (1.0 in/min) for a period of about 250 s, as can be observed in Figure 4.11. The load that resulted is shown in Figure 4.12. The specimen resisted the applied load with a near constant stiffness, until about 170 s into the test. At this point, the outer truss pulled free of the top plate. As in the case of the toe-nailed connections, the tension due to the overturning moments appeared to play a major role in the failure, which can be seen in Figure 4.10. Also as in the prior test, the failure mode can be characterized as nail withdrawal from the top plate.

Figure 4.10. Failure of hurricane clip connection with lateral load.

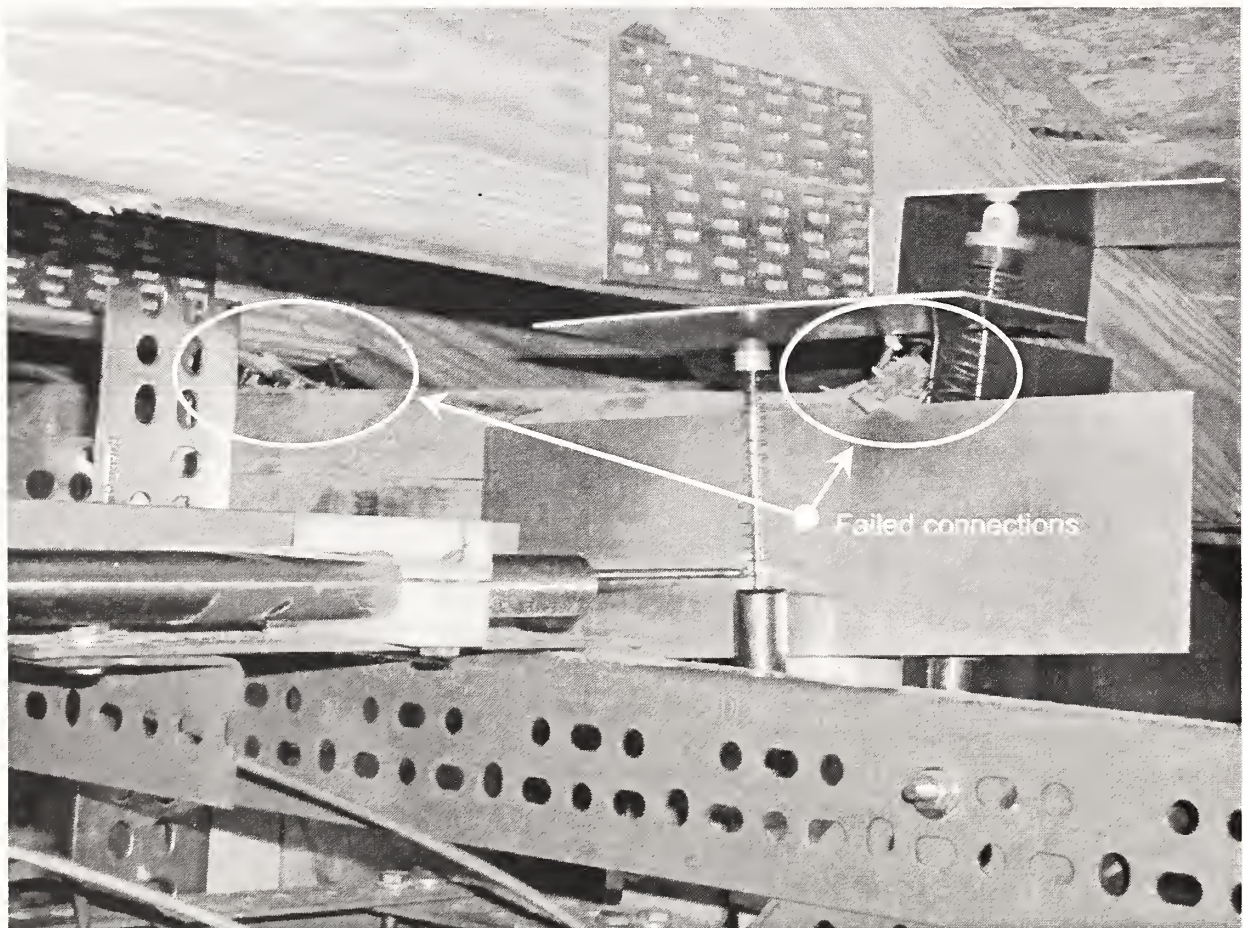
Figure 5.1. Failure of toe-nailed connection with cyclic load.

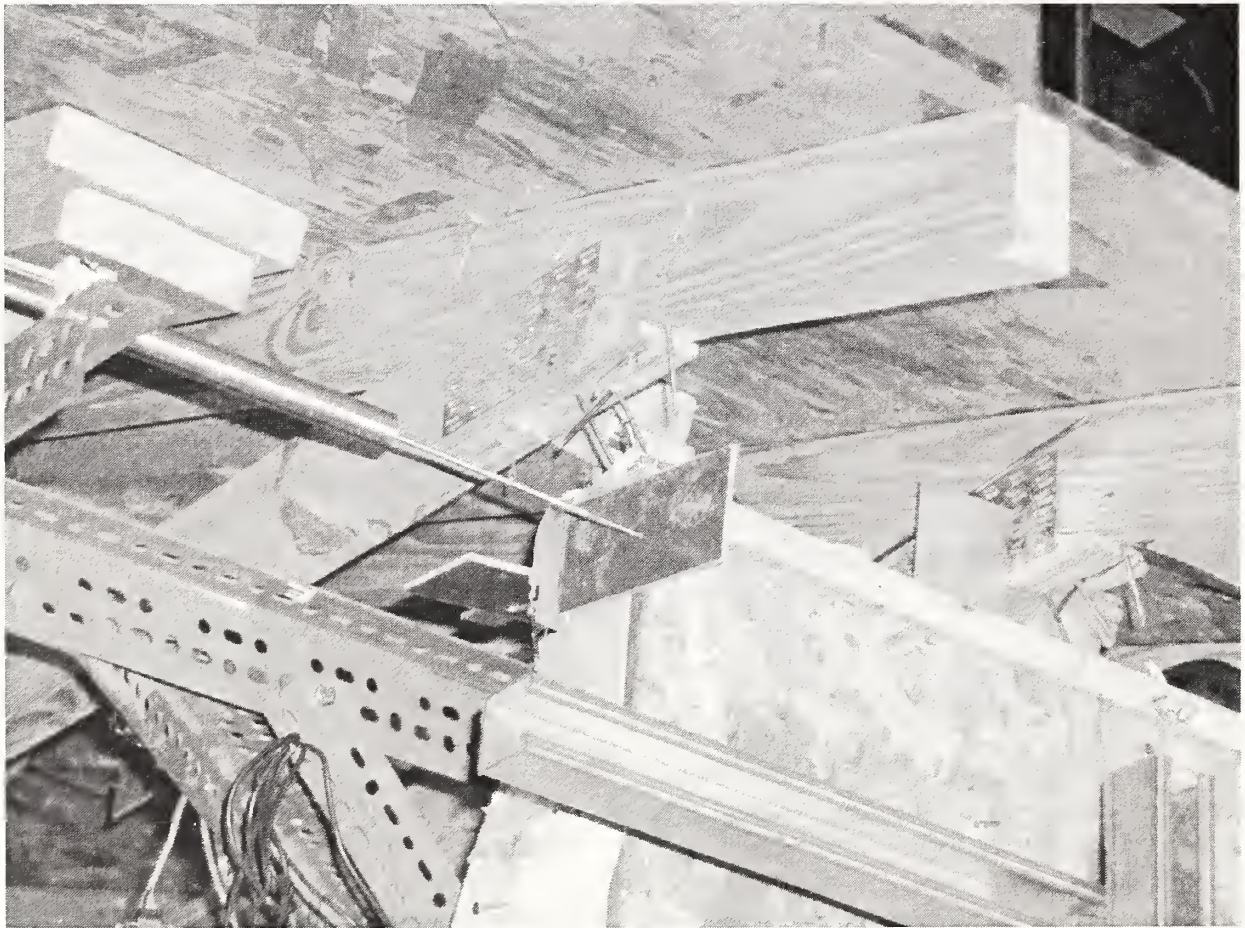
Figure 6.1. Failure of toe-nailed connection with combined load.

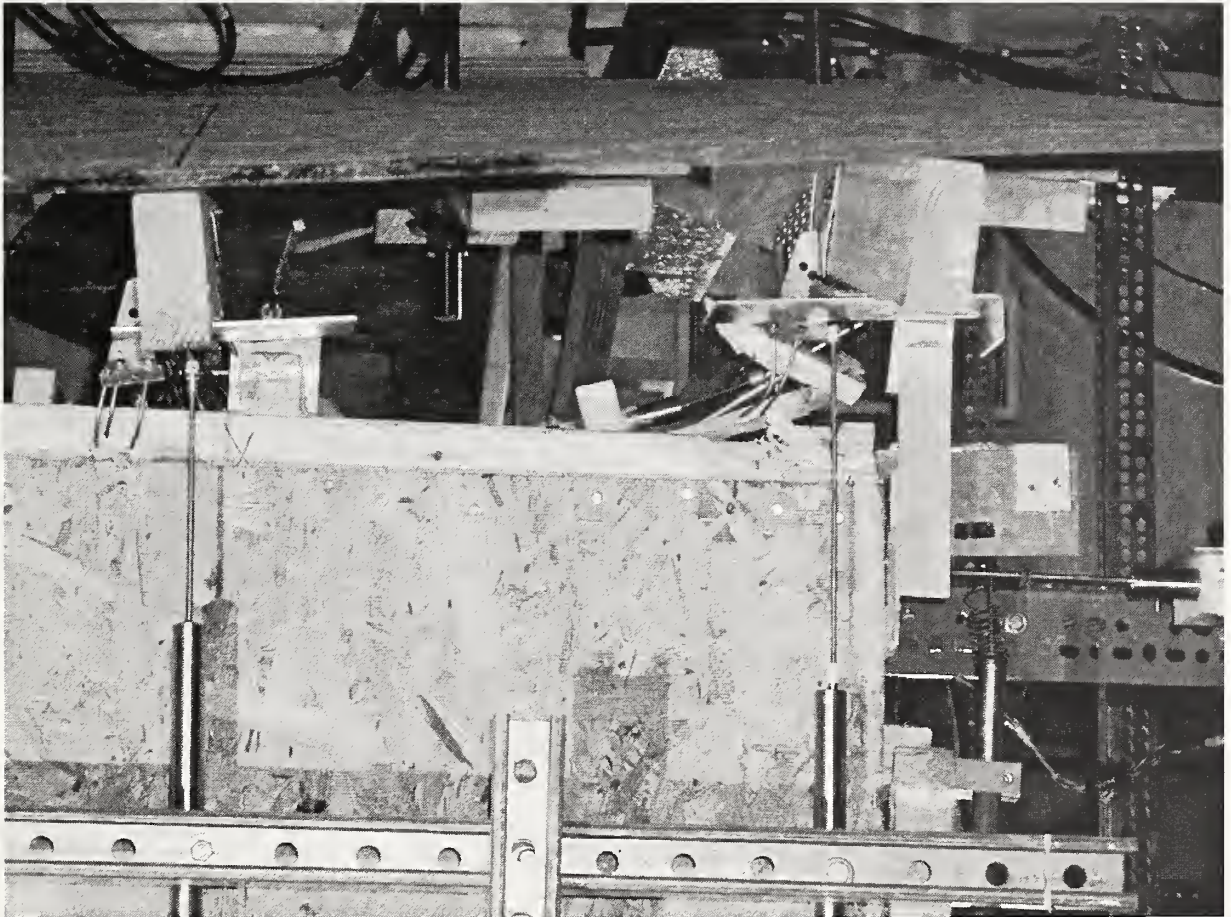
Figure 6.10. Failure of hurricane clip connection with combined load.
